Cracked tooth diagnosis and treatment: An alternative paradigm

John S. Mamoun¹, Donato Napoletano²

How to cite this article: Mamoun JS, Napoletano D. Cracked tooth diagnosis and treatment: An alternative paradigm. Eur J Dent 2015;9:293-303.

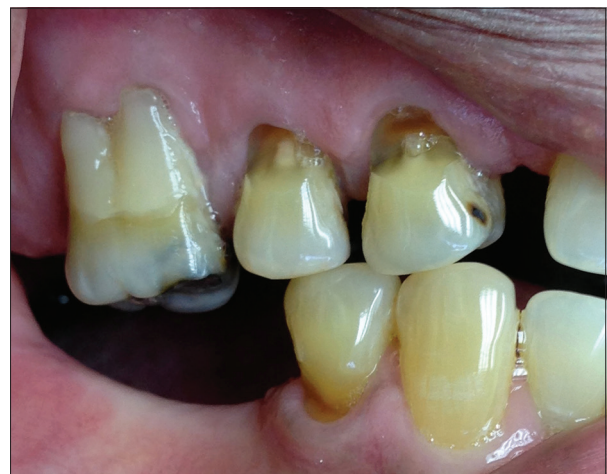
Figure 1: A lateral view of two premolars that experience heavy occlusal forces due to lack of molar occlusion, which also have abfraction lesions

protruding maxillary molar palatal cusps^[12] occluding powerfully into the mandibular molar central grooves. Maxillary premolars, which often have steep inclines on nonfunctional cusps that result in torque forces during mastication, are more likely to crack than mandibular premolars, which experience mostly compression forces due to opposing teeth occluding into the mandibular premolar buccal cusps. A posterior tooth with a class II restoration may be the source of discomfort if it is the only remaining (or restored) posterior tooth in that quadrant, or if it shows signs of occlusal trauma or an abfraction lesion [Figures 1 and 2].

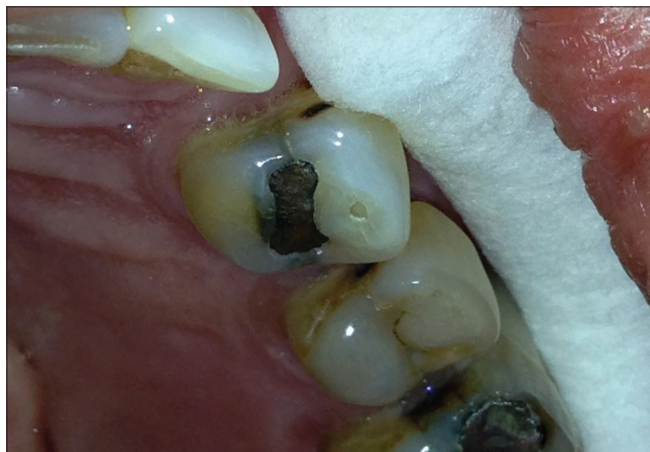
Figure 2: An occlusal view of the premolars from Figure 1 also shows marginal ridge fractures

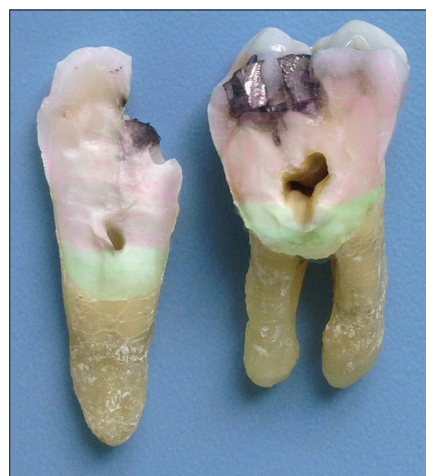
Figure 3: The palatal root (left) disconnected from the buccal roots (right) of this maxillary molar via a furcation fracture. Here, a stress plane superior to the pulp chamber floor (pink) and another stress plane between the pulp chamber floor and the external tooth surface between the roots (green) both fractured, resulting in complete palatal root disconnection

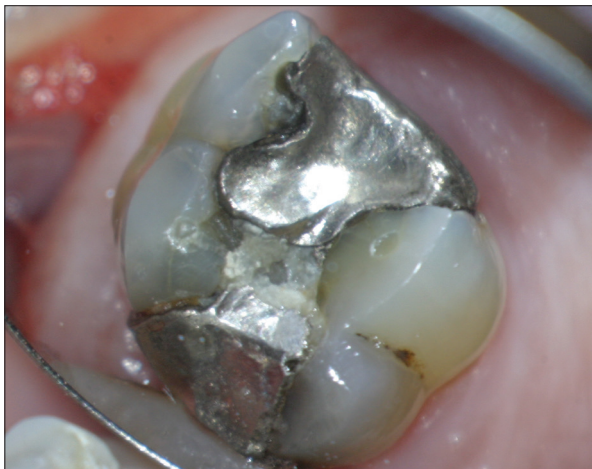
Figure 6: This maxillary molar with a class II restoration was sensitive

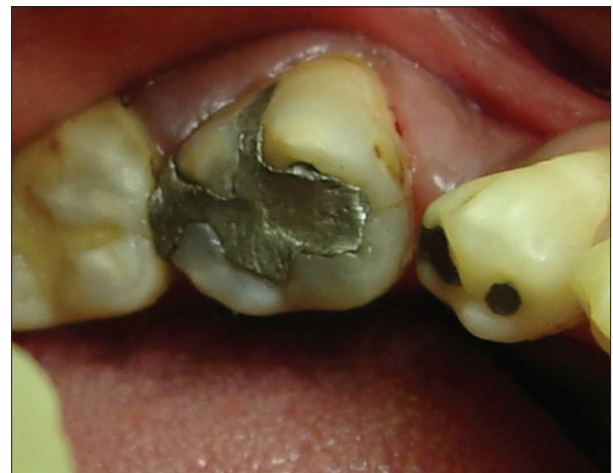
Figure 5: A molar with a class II restoration and a crack in the untouched marginal ridge

cracks [Figure 5]. Furthermore, if a tooth with a class II restoration is sensitive, a dentist may remove the restoration to observe if a crack line exists underneath the restoration [Figures 6 and 7]. If no crack line is observed, the dentist (conservatively) replaces the restoration. However, an observed crack line may be interpreted as a partial fracture of a furcation stress plane that is presumed to exist in that tooth, where the tooth has a missing marginal ridge on one side (due to the restoration), and a compromised marginal ridge on the other side (due to the crack). Here, a crown and possibly endodontic treatment may be needed.

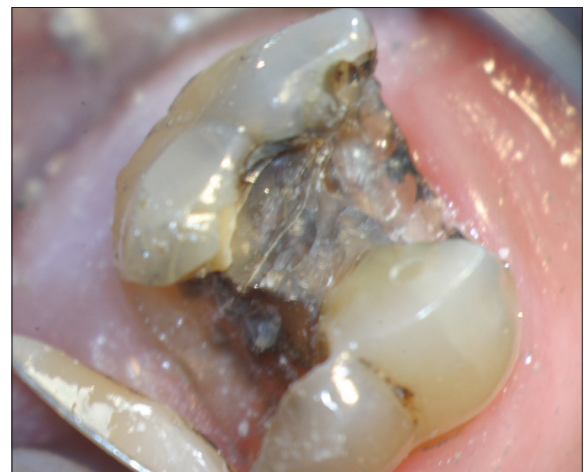
Figure 7: Removal of the amalgam reveals the crack lines of a cuspal fracture plane along the apical-axial aspect of the buccal cusps and a partially fractured furcation stress plane

Cuspal fractures can be caused by forces put on existing restorations during masticatory cycles; these forces stress the stress planes located apical to the cusps that retain the restorations.^[32,40] With an amalgam, the preparation axial walls converge toward the occlusal, so occlusally directed forces on the restoration stress the cuspal stress planes. The walls of an inlay preparation diverge toward the occlusal, so apically directed forces stress the cuspal stress planes. If the dentist removes the restoration and observes the dried preparation surface, the dentist may observe a crack line located at what was previously the apical-lateral aspect of the restoration [Figure 7].

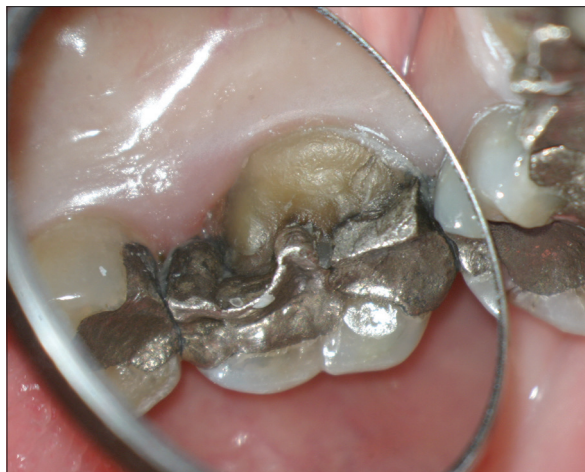
Figure 8: A complete fracture of a molar lingual cusp shows a void that is bounded axially by a large mesial-occlusal-distal amalgam that the cusp was helping to retain

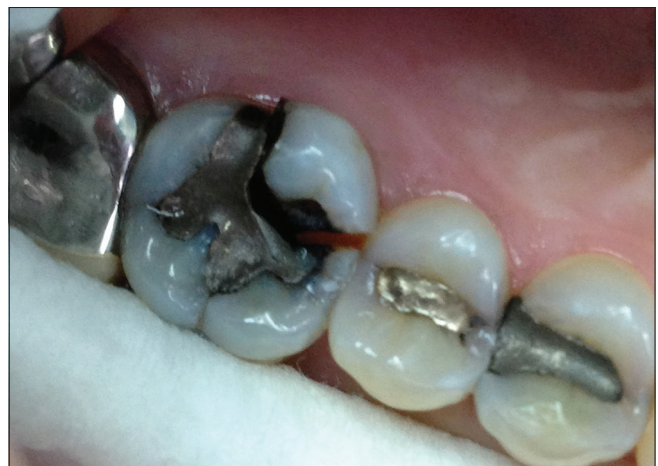
Figure 9: A complete fracture of the mesial-lingual cusp of a maxillary molar, retained only by gingival tissue

Cuspal fracture planes can develop inside a tooth without showing visible crack lines on the external surface of the tooth, if the fracture plane is subgingival, or if the fracture plane has not expanded enough in area to reach the external tooth surface [Figure 9].

A cusp may fracture off the tooth but be retained by gingival tissue [Figure 9]. When the patient occludes, the cracked piece may jab the gingiva but only cause soft tissue pain. Removing the loose piece may indefinitely relieve sensitivity, and with polishing the tooth may be indefinitely stable, without requiring further restoration. When restoring the tooth with a direct restoration, microscopes facilitate observing that an opposing pointy plunger cusp does not occlude into the restoration isthmus.

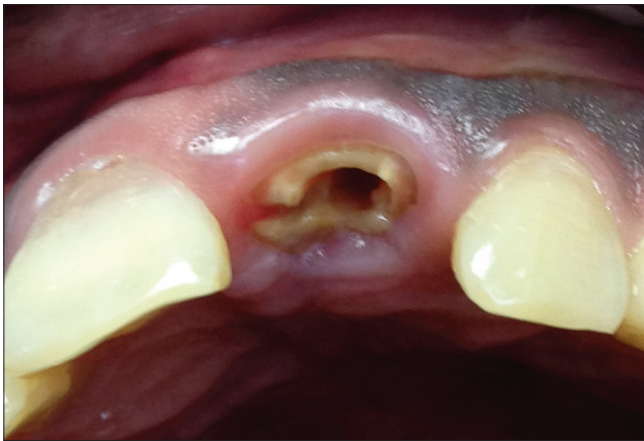
Figure 10: A maxillary central incisor showing a root fracture and a gingival interface fracture, due to a post and core that fractured the root due to lack of ferrule tooth structure

A root fracture is a fracture of a stress plane contained within only one root, such that complete fracture of the stress plane would not result in disconnection of one root from another [Figure 10]. Root fractures,^[3,48] which are often catastrophic fractures,^[49] can result from caries in root structure or from roots containing intra-canal retainers^[2,50] where the tooth lacks ferrule tooth structure, which results in a post putting more stress on the root.^[51,52] Roots can also be fractured via use of excessive pressure while obturating root canals;^[53-56] using excessive vertical forces to push a peeso reamer into a root while making a postspace, particularly if the peeso reamer is too wide in diameter compared to the diameter of the canal; skipping sizes of peeso reamers while making a postspace, such as moving from a #1 peeso reamer directly to a #3 peeso reamer, particularly when preparing postspaces in thin roots, which are common with premolars or mandibular incisors; or radicular micro-cracks^[45,57] created during apico-ectomy procedures using ultrasonic retro-tips. One study^[53] showed that the

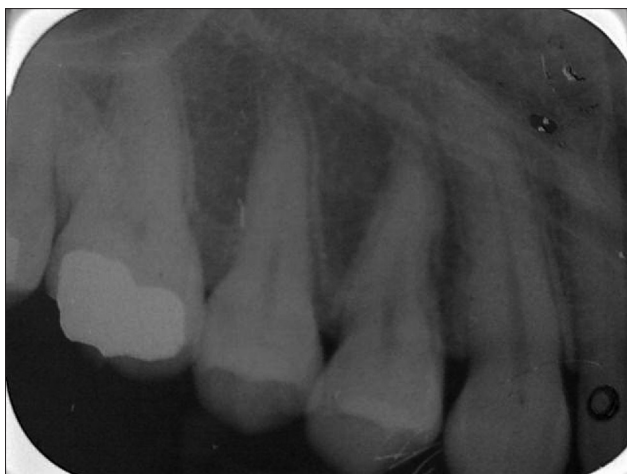
Figure 11: A radiograph of a maxillary molar that contains minimal remaining coronal tooth structure that can help to retain the large mesial-occlusal-distal restoration. The remaining tooth structure is under higher stress levels from retaining the restoration. Part of the distal aspect of the remaining tooth structure fractured, showing that the remaining tooth structure is not strong enough to retain this direct restoration without developing cracks

that is deep in an occlusal-to-apical direction [Figure 11], where there is minimal height of tooth structure from the gingival interface level of the tooth to the apical level of the restoration. A crown and possibly a post may be needed to retain the supra-gingival restoration. However, if the restoration has a buccal or lingual component that reaches the CEJ area of the tooth, then the restoration, on the radiograph, may appear deeper than it is in reality.

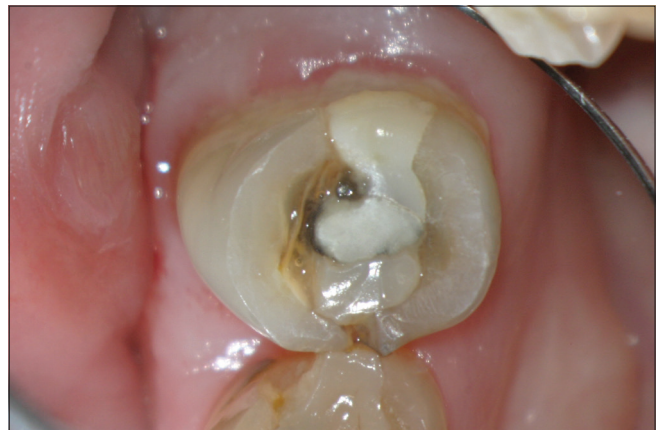
Figure 12: A sensitive premolar shows a cleft and a microscopically thin crack line, with a minimal color contrast with surrounding tooth structure

Microscopes facilitate observation of microscopic crack lines that may show minimal color contrasts against a desiccated tooth surface [Figure 12], without needing trans-illumination or dyes to observe crack lines. Microscopically precise tactile sensation permits verification of a crack by associating the tactile sensation of an explorer tip falling into a cleft with the microscopic point on a crack line where the tip is located. Microscopes permit detecting microscopic

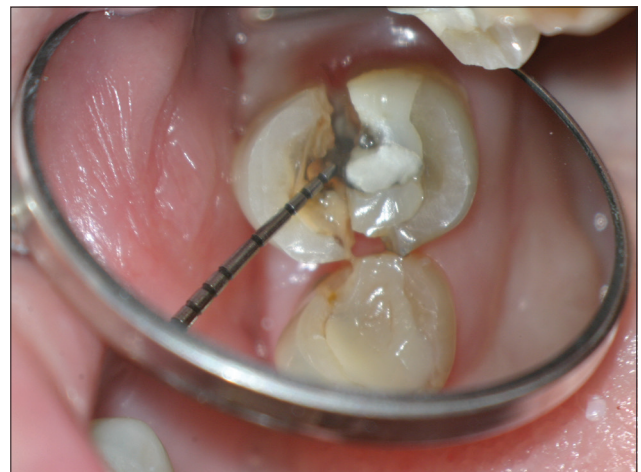
Figure 13: A periodontal probe in the premolar separates the cracked piece
